## Condon Elementary School

### Structural Assessment of Existing Building

Gary Livermore, PE, Architect  
Livermore Architecture & Engineering

March 24, 2022  
Project Number: 221088.00

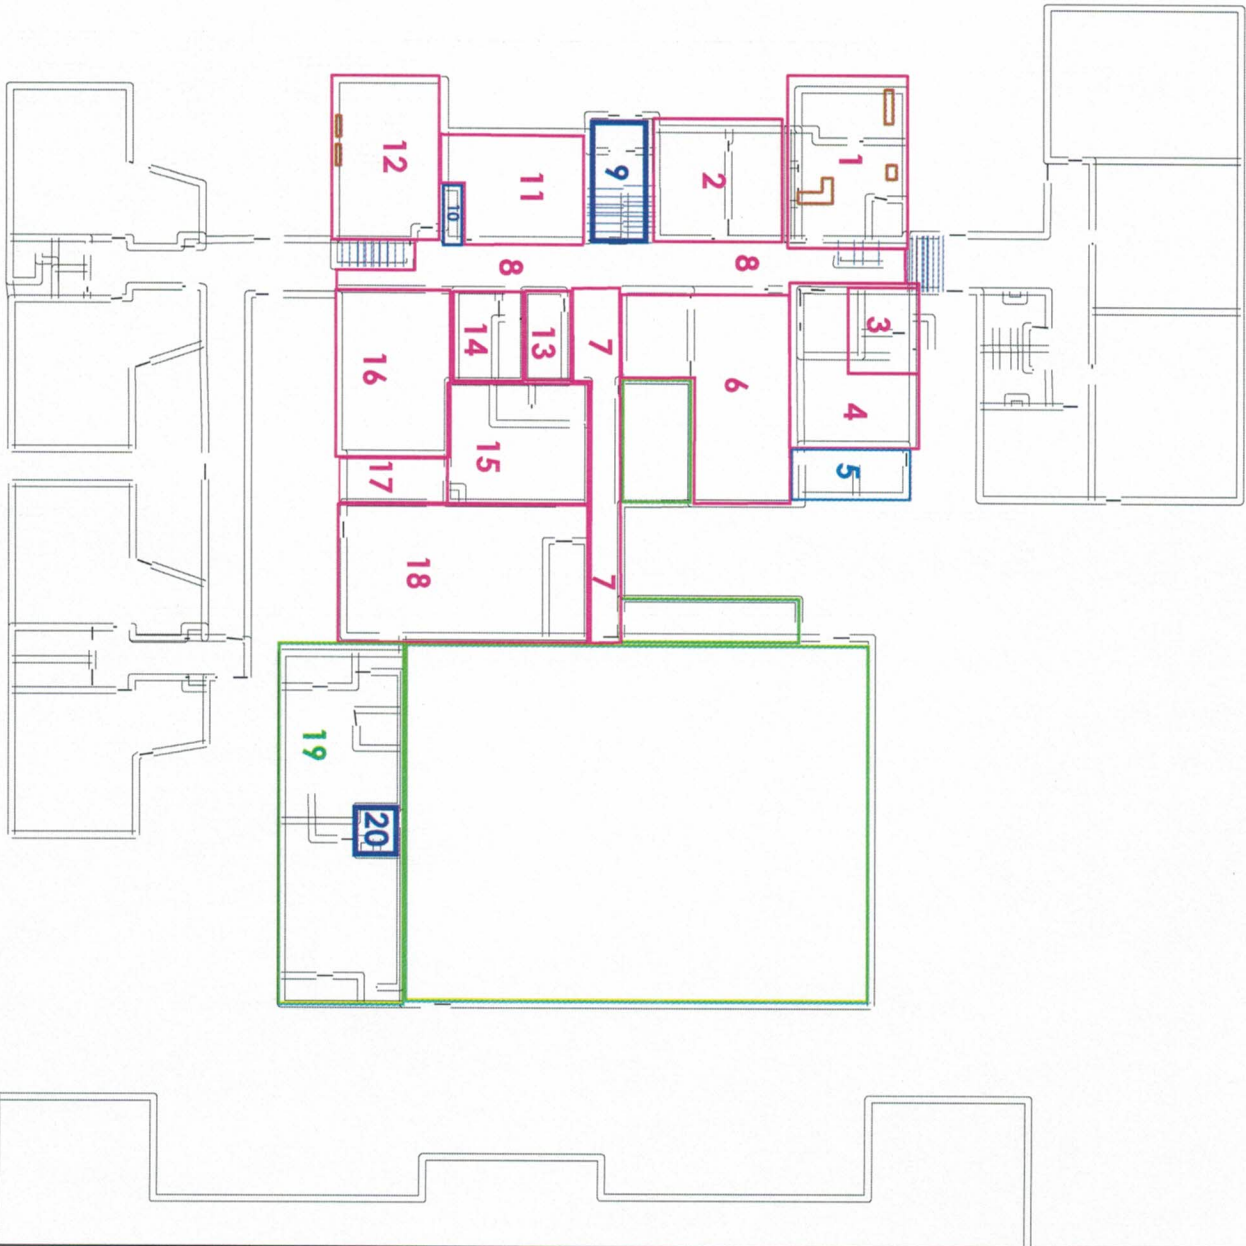
**Figure 3-21**  
**Functional Area 1:**  
**Overview**  
Condon HBM Report

- NOTES:**
- Numbers 1-20 corresponds to each individual figure.
  - Magenta outline indicates the presence of asbestos.
  - Blue outline indicates no presence of asbestos.
  - Green outline indicates no samples collected.

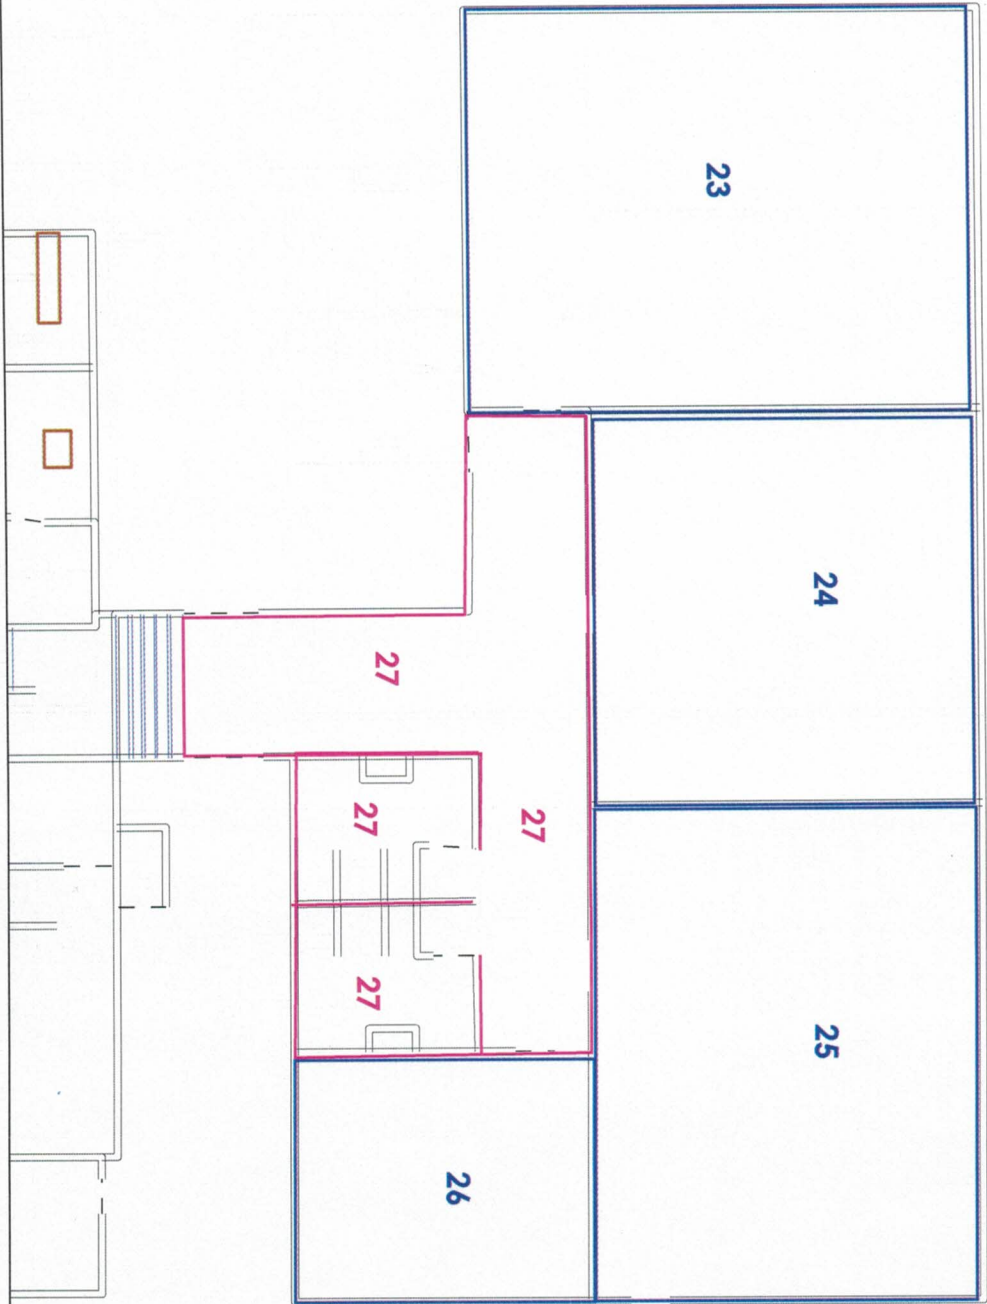
**Figure 3-39**  
**North Wing:**  
**Overview**  
Condon HBM Report

-Magenta outline indicates the presence of asbestos.

-Blue outline indicates no presence of asbestos.

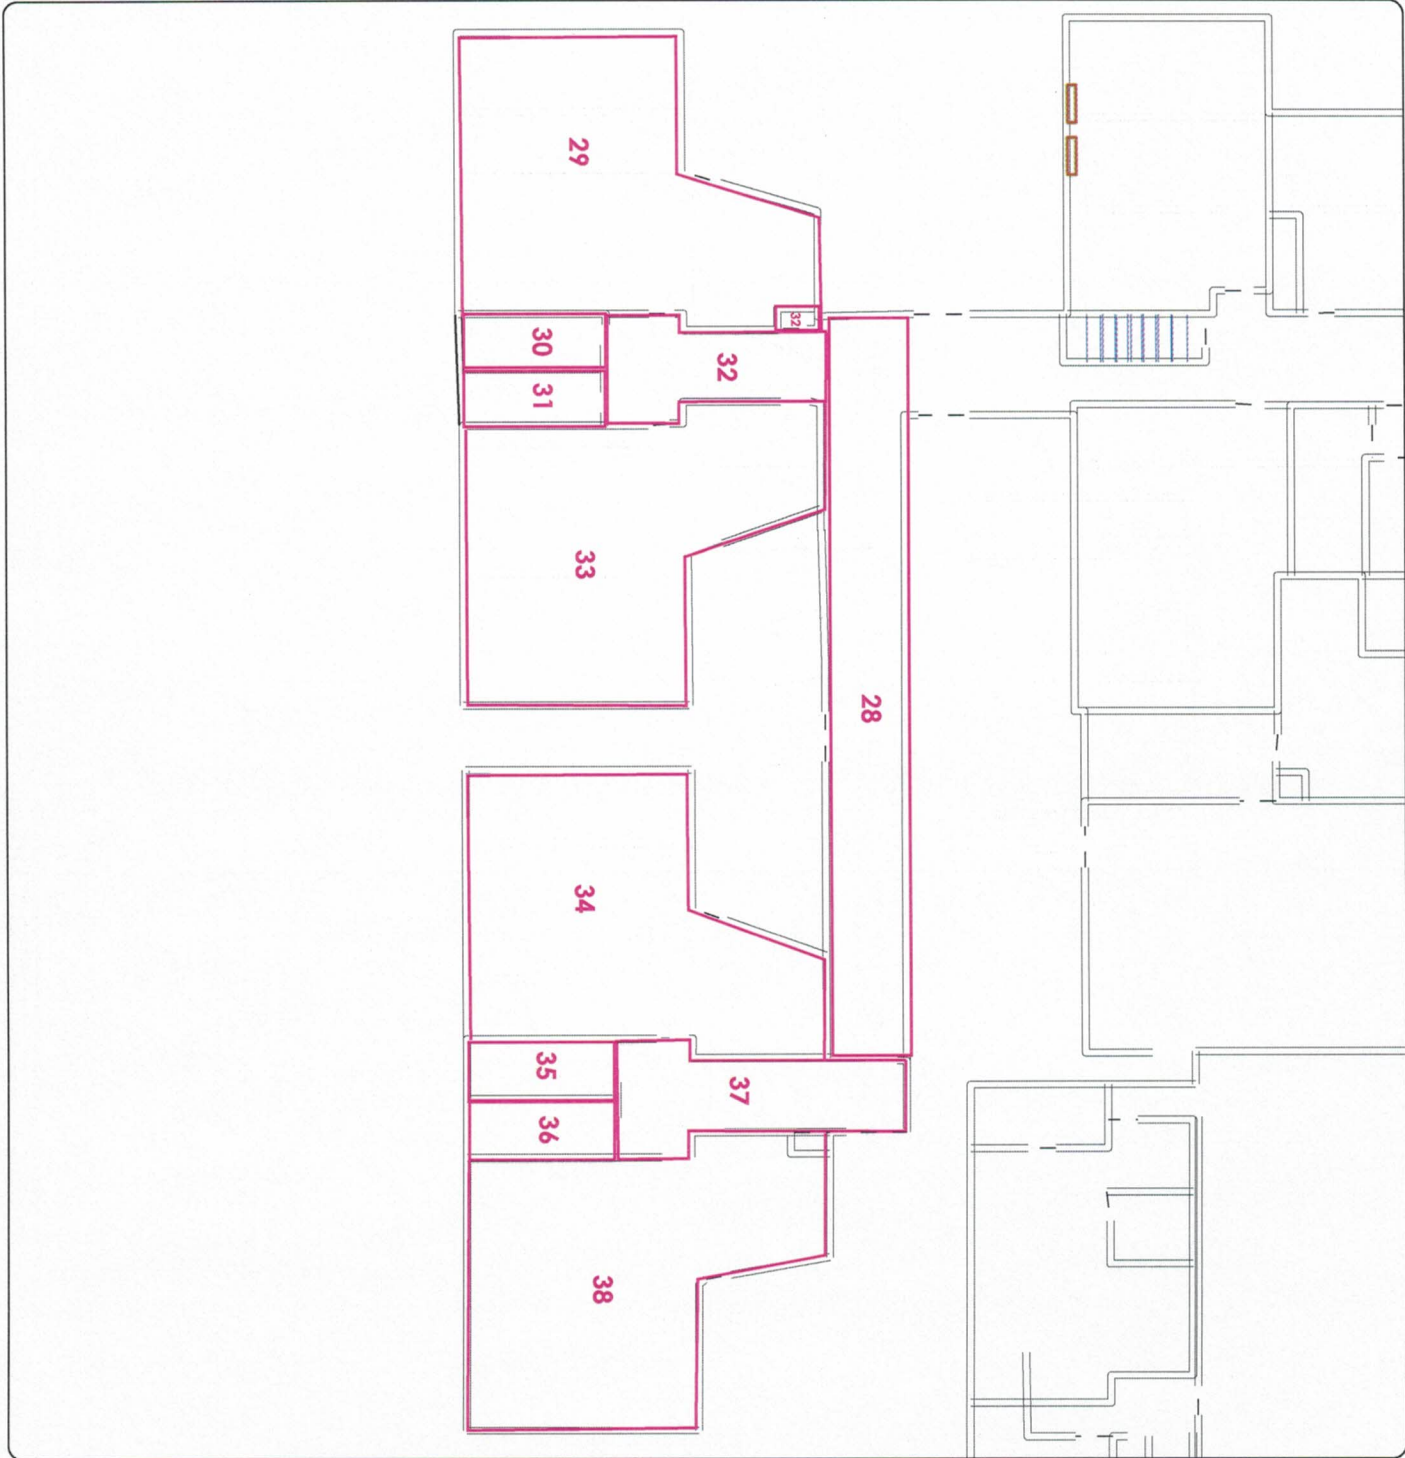
**Figure 3-40**  
**South Wing:**  
**Overview**  
Candon HBM Report

-Numbers 28-38 corresponds to each individual figure.  
-Magenta outline indicates the presence of asbestos.

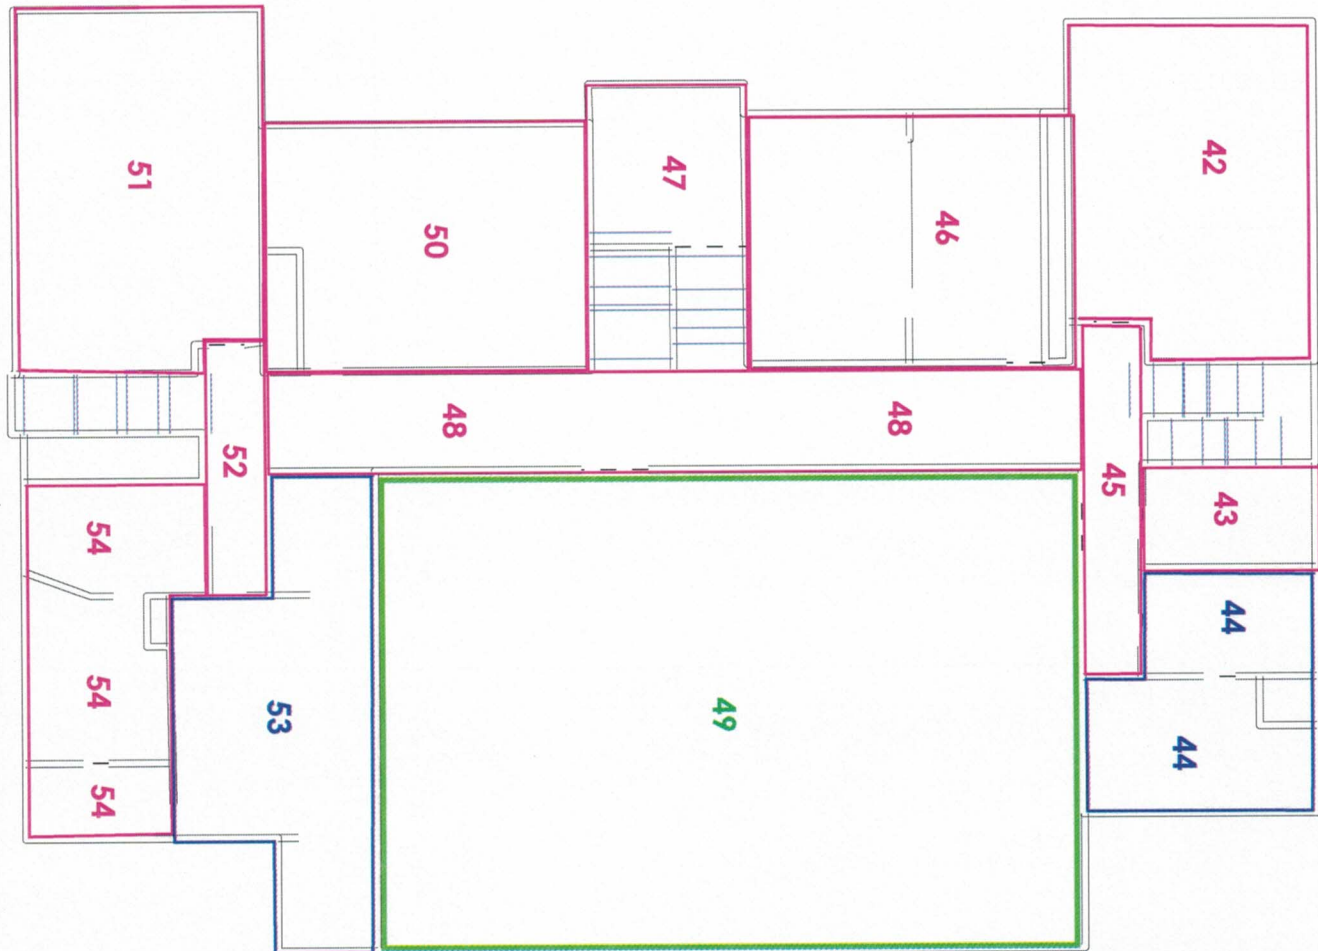
**Figure 3-41**  
**Functional Area 2**  
**Second Floor:**  
**Overview**  
Condon HBM Report

- Numbers 42-54 corresponds to each individual figure.
- Magenta outline indicates the presence of asbestos.
- Blue outline indicates no presence of asbestos.
- Green outline indicates no samples collected.
